# **INDOOR AIR QUALITY ASSESSMENT**

**Wayland Town Hall  
41 Cochituate Street  
Wayland, Massachusetts**

Prepared by:  
Massachusetts Department of Public Health  
Bureau of Environmental Health Assessment  
Emergency Response/Indoor Air Quality Program  
July 2003

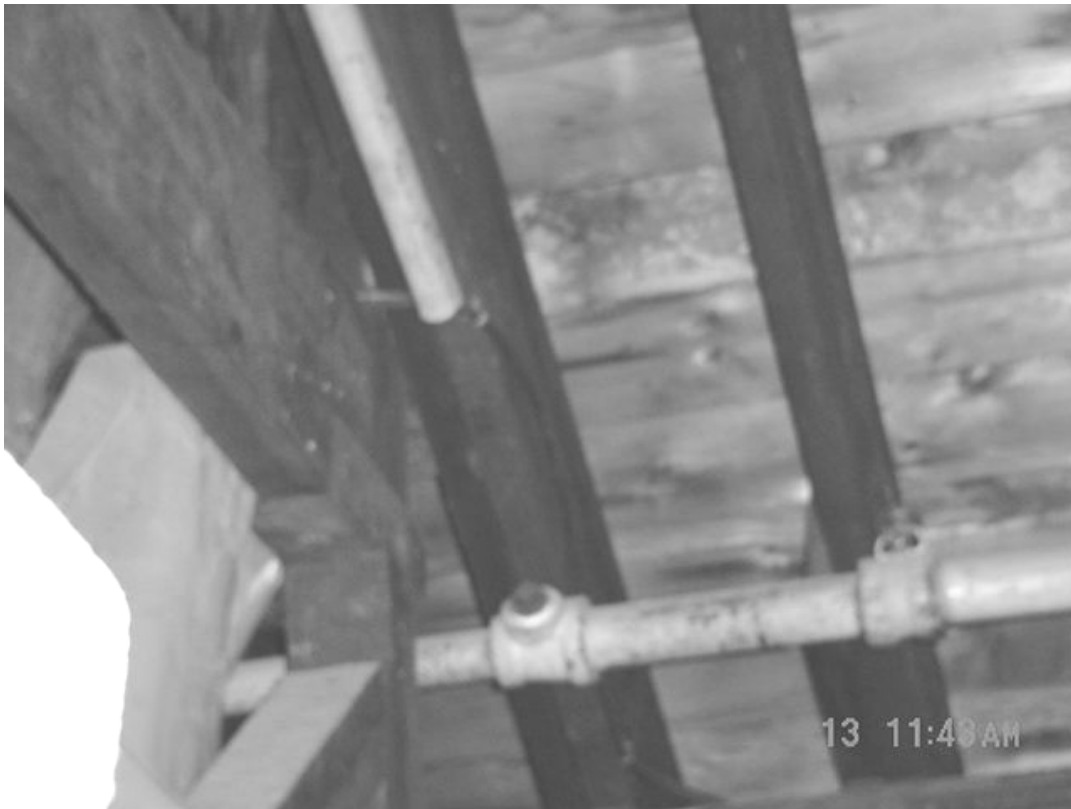
**Picture 1**

In January 2003, the building reportedly experienced extensive water damage to ceilings, floors and walls caused by flooding resulting from the freezing of sprinkler pipes in the attic (see Picture 1). Service Master Inc. was hired to dry out carpeting and clean/disinfect areas of water damage. Service Master Inc. dried carpeting by fanning and heating carpeted areas. The company also drilled holes in walls to dry/ventilate wall cavities.

**Portion of the Sprinkler System in the Attic Where Leak Occurred**

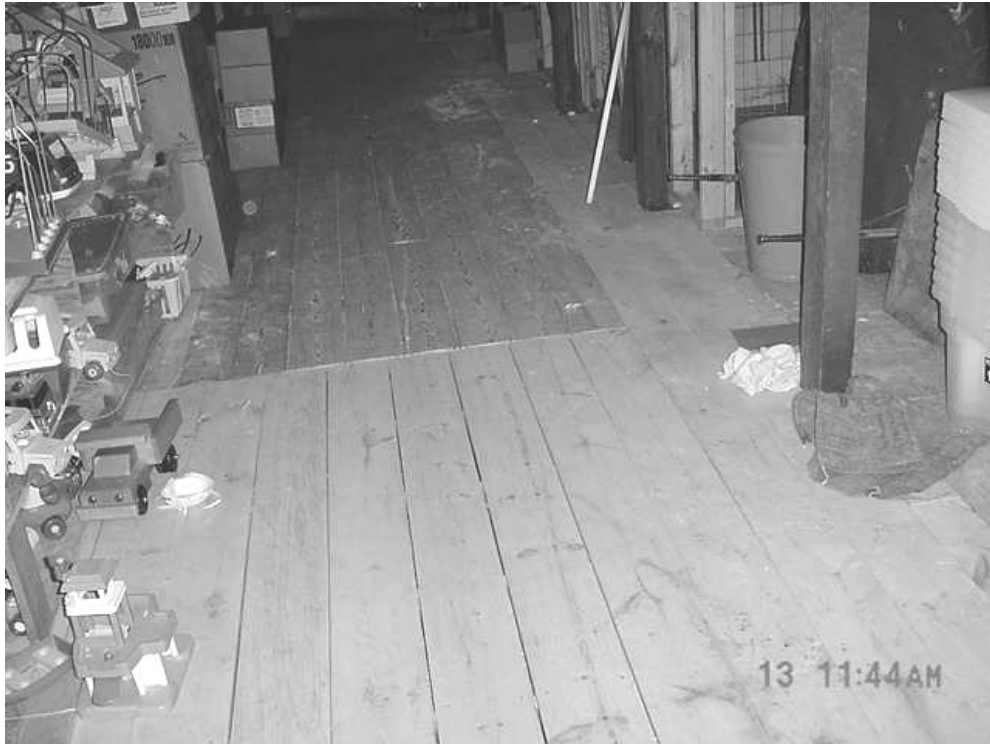
**Picture 2**

Employees were relocated from the building for several months during remediation of the building. As part of this remediation, carpeting, ceiling tile systems and wood flooring materials

were replaced (see Picture 2). Wayland town officials also sampled water in the crawlspace since propylene glycol was used as an antifreeze agent in the sprinkler system that ruptured. This sampling and analysis test was done to determine appropriate methods for disposal of crawlspace water.

**Portions of the Wooden Floor in the Attic Replaced (Light Colored)**

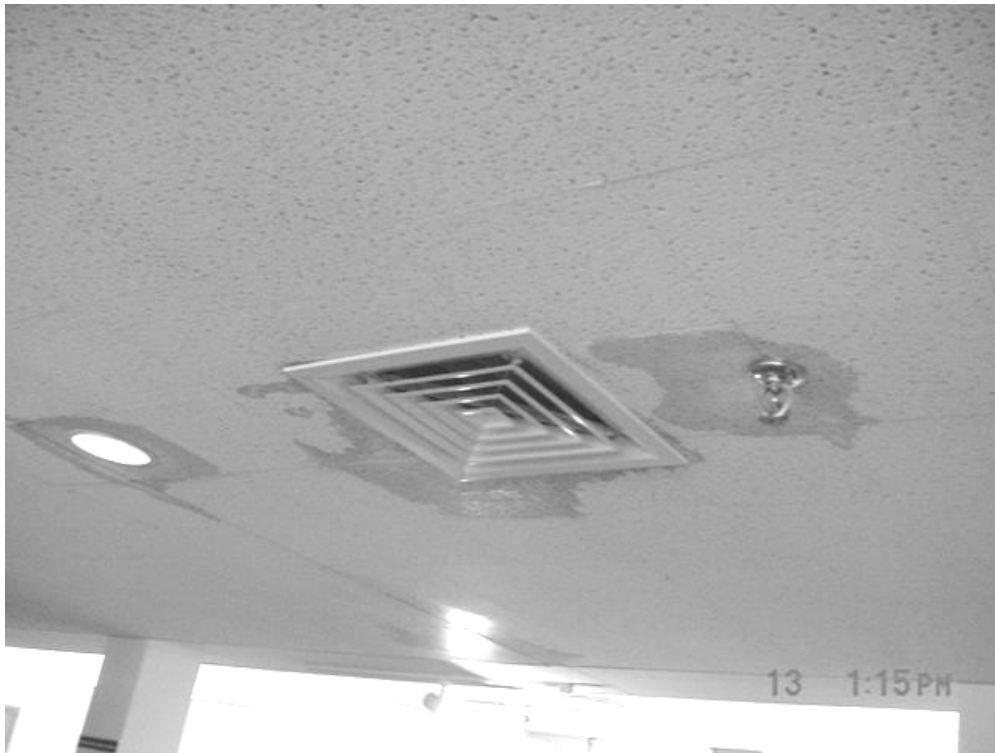
**Picture 3**

Fresh, heated air is supplied by air-handling units (AHUs) located in the attic. Ventilation is delivered to occupied areas via ceiling-mounted air diffusers (see Picture 3) connected to ductwork that runs back to AHUs. Return/exhaust air is drawn into ceiling vents and ducted back to AHUs. Prior to the assessment, town maintenance personnel deactivated AHUs reportedly to prevent the distribution of foul odors believed to be emanating from the crawlspace. Therefore during the assessment, no mechanical means of ventilation was being provided.

**Ceiling-Mounted Air Diffuser**

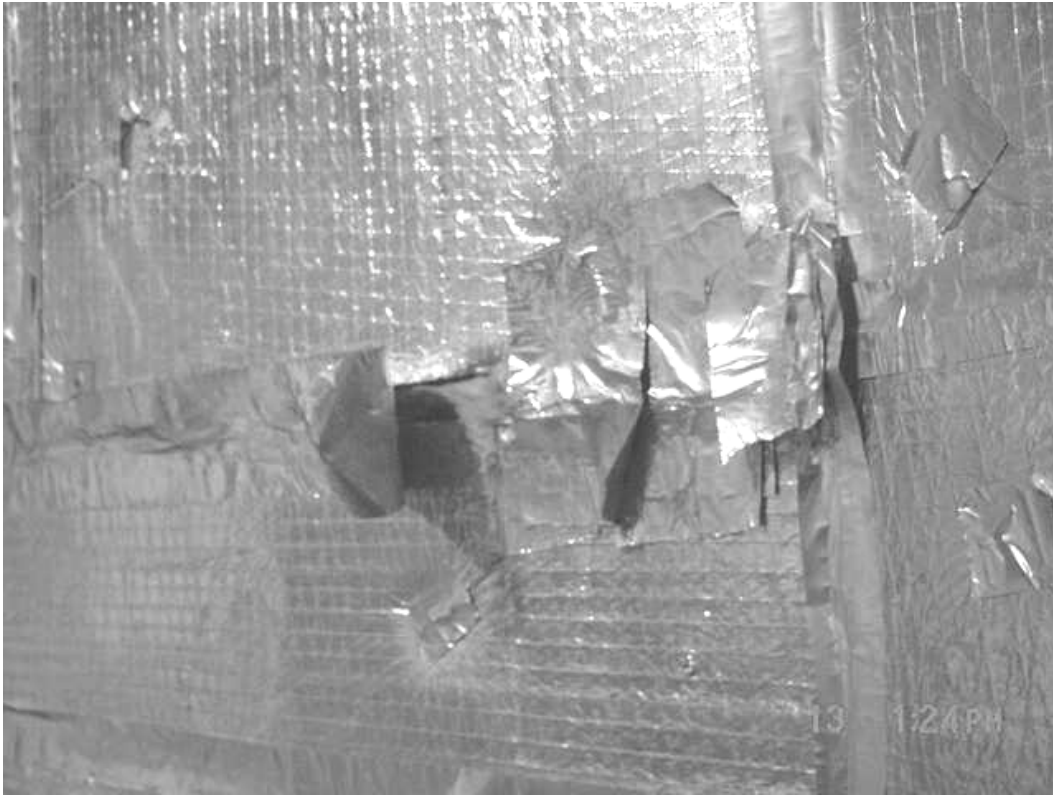
**Picture 4**

**Breaches in the Integrity of Fiberboard Ductwork in Attic**

6. In order to improve indoor air quality, an increase in the percentage of fresh air supply into the HVAC system may be necessary.
7. Inspect and seal all breaches in the fiberboard ductwork in the attic to gain temperature control and reduce heating/cooling loss.

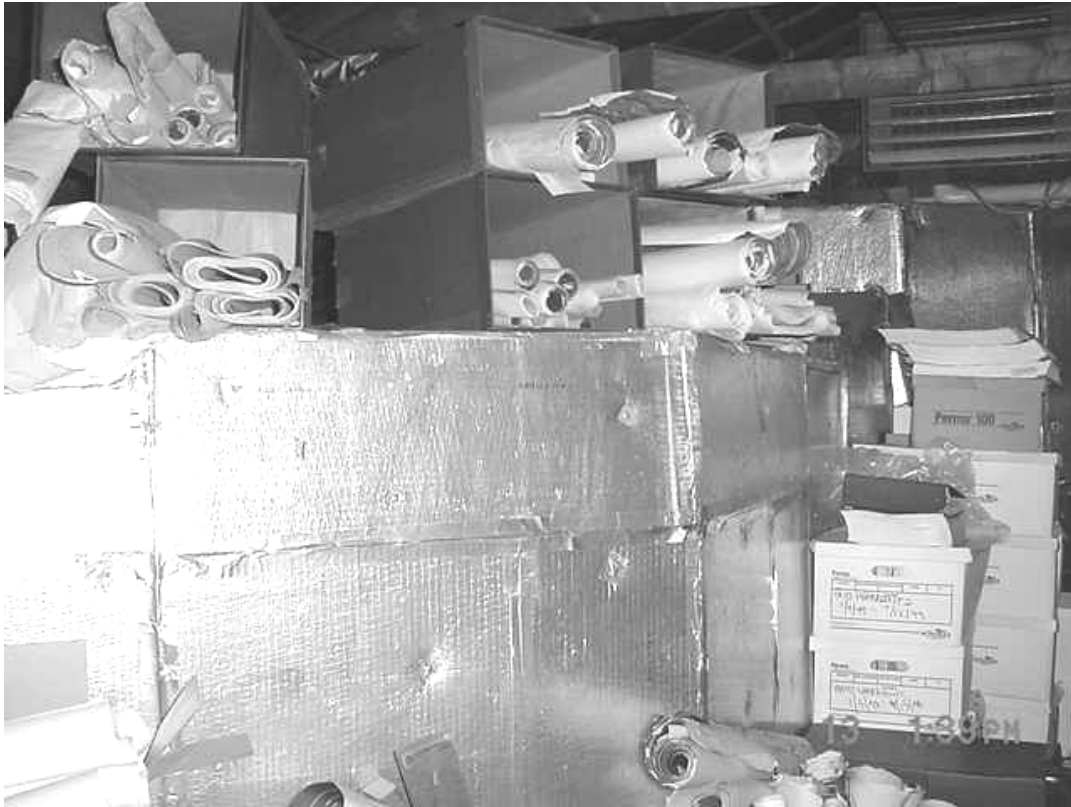
**Picture 5**

**Items Stored on and around Fiberboard Ductwork in Attic**

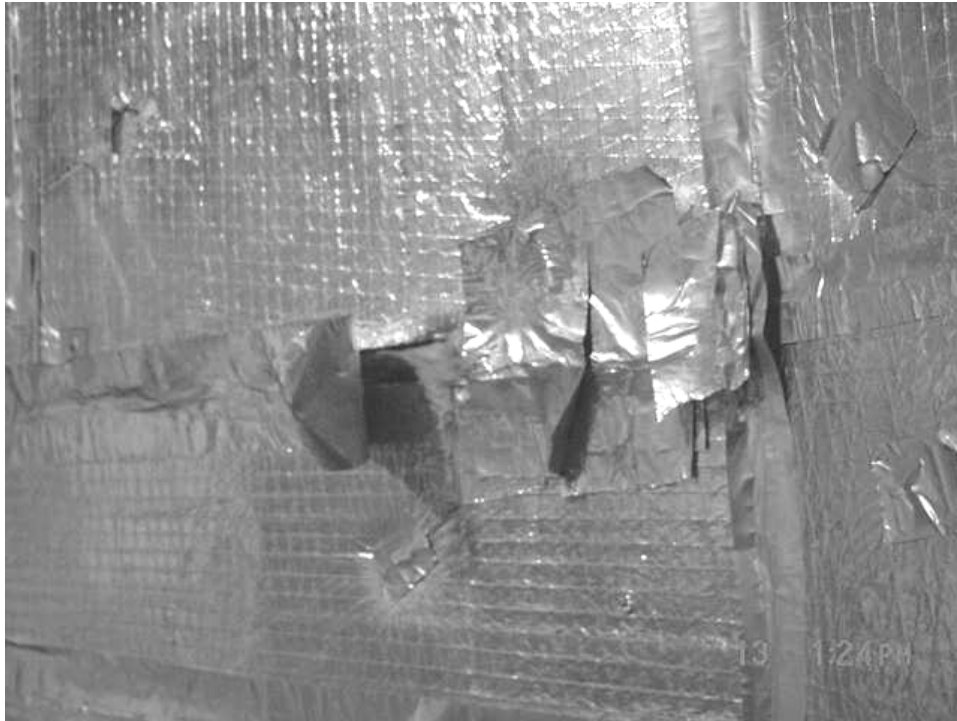
**Picture 6**

Ductwork in the attic is constructed of fiberboard material that is held together by duct tape. In many instances breaches were observed in the ductwork where it had become damaged or duct tape was failing (see Picture 6). These breaches can allow heated or cooled air to move into the attic space, creating an imbalance in the ventilation system. This imbalance can lead to temperature/comfort complaints.

**Breaches in the Fiberboard Ductwork in the Attic**

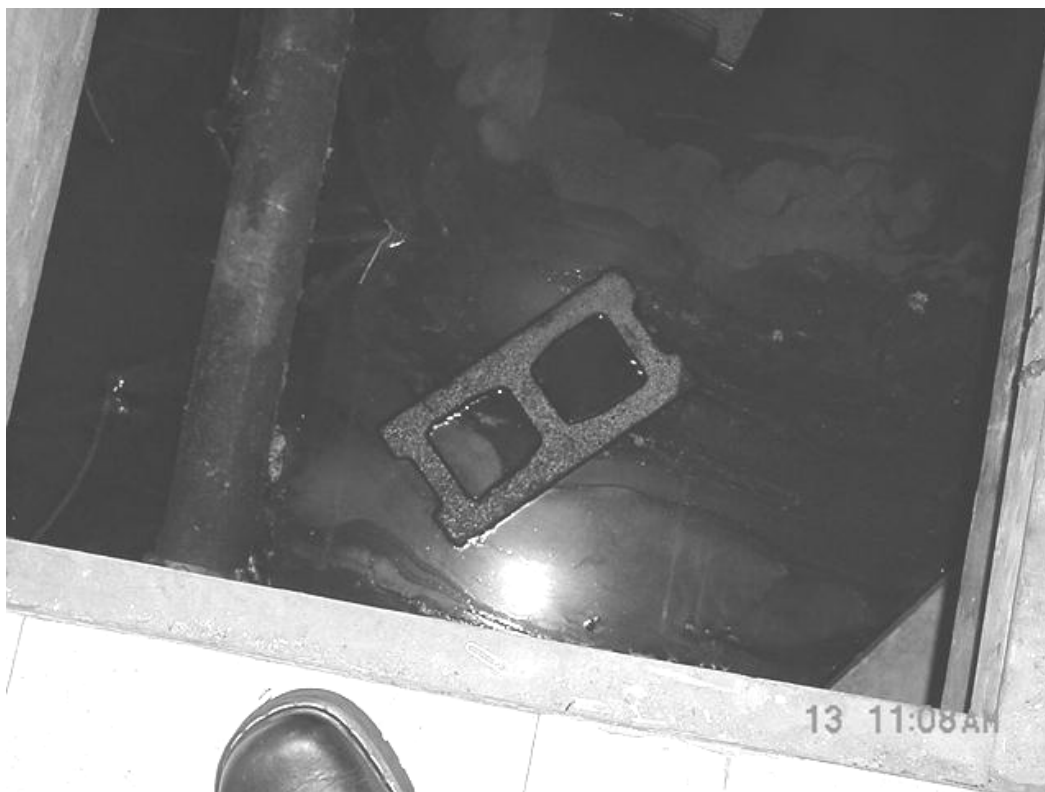
**Picture 7**

**Standing Water in Crawlspace**

1. Seal utility holes and other potential pathways to eliminate pollutant paths of migration from the crawlspace to the first floor.
2. Continue with plans to pump water from crawlspace in a manner consistent with Massachusetts Department of Environmental Protection (MDEP) regulations.

1. Explore options for providing a barrier between the dirt floor and crawl space. Consider consulting a building engineer, hydrogeologist and/or an environmental engineering firm about possible options to eliminate water accumulation in the crawlspace. Once water is removed, replace water damaged insulation. Consider replacing with a waterproof insulating material.

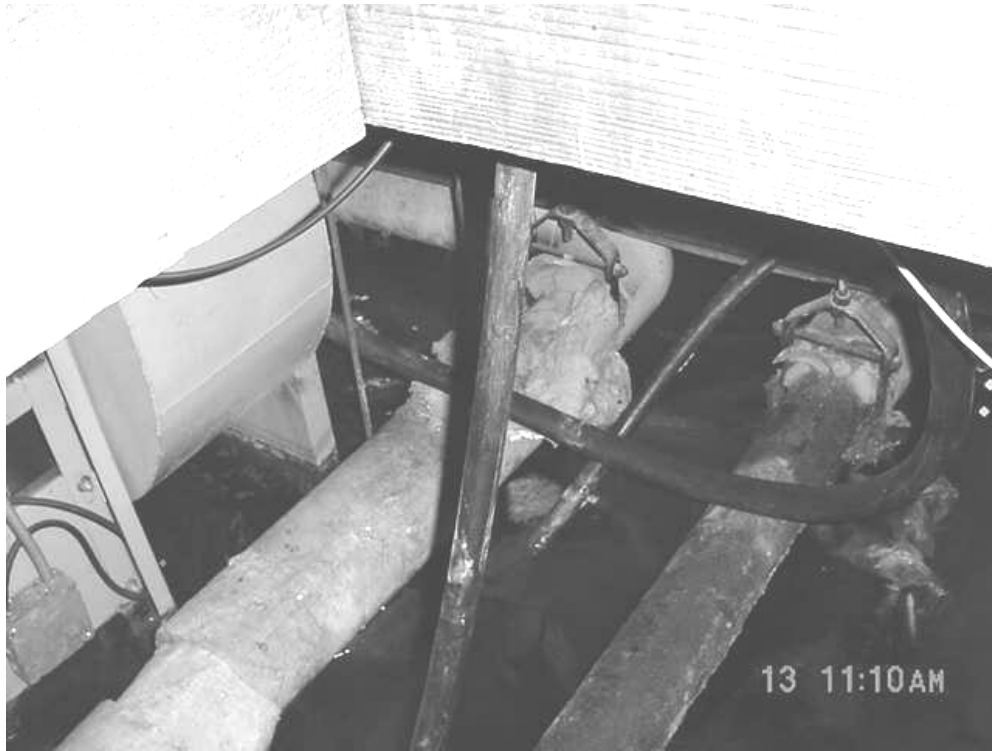
**Picture 8**

**Water Damaged Pipe Insulation**

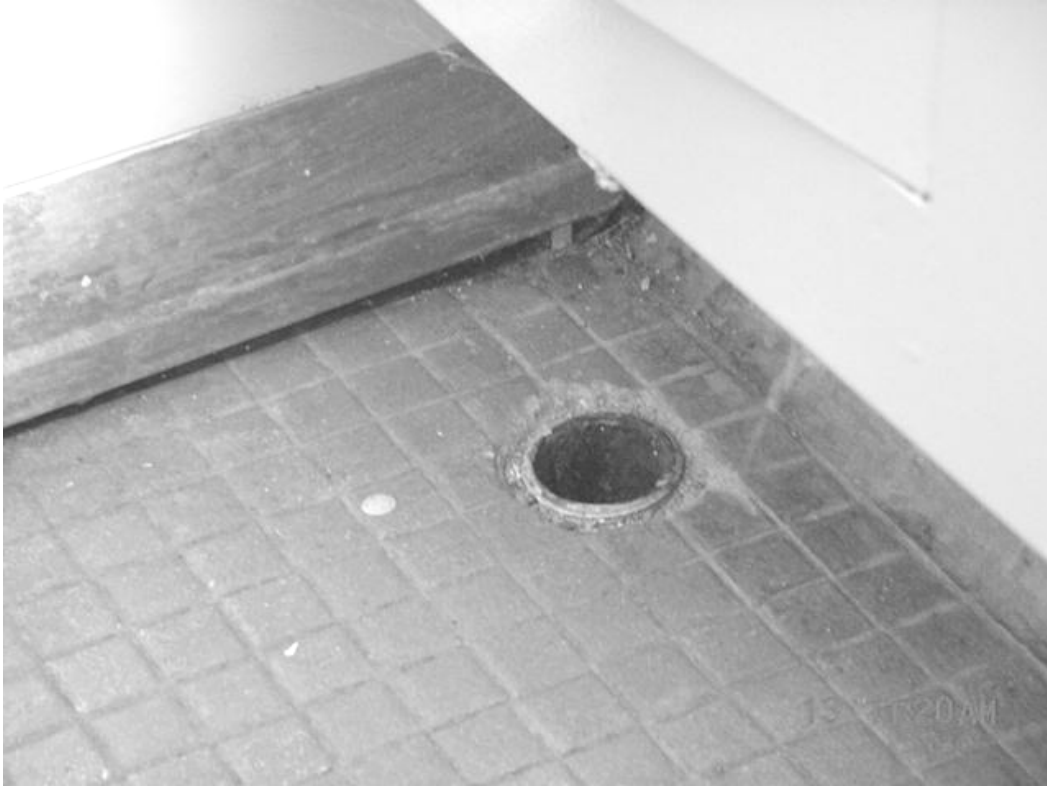
**Picture 9**

BEHA staff detected strong odors in the vicinity of the first floor restrooms. A utility hole was observed in the floor of the men's room that was open to the crawlspace (see Picture 9). A prominent draft was noted from the hole. Open utility holes, spaces around access plates or any other breaches between the crawlspace and the first floor can provide pathways for odors to migrate into occupied areas.

**Open Utility Hole in First Floor Men's Room**

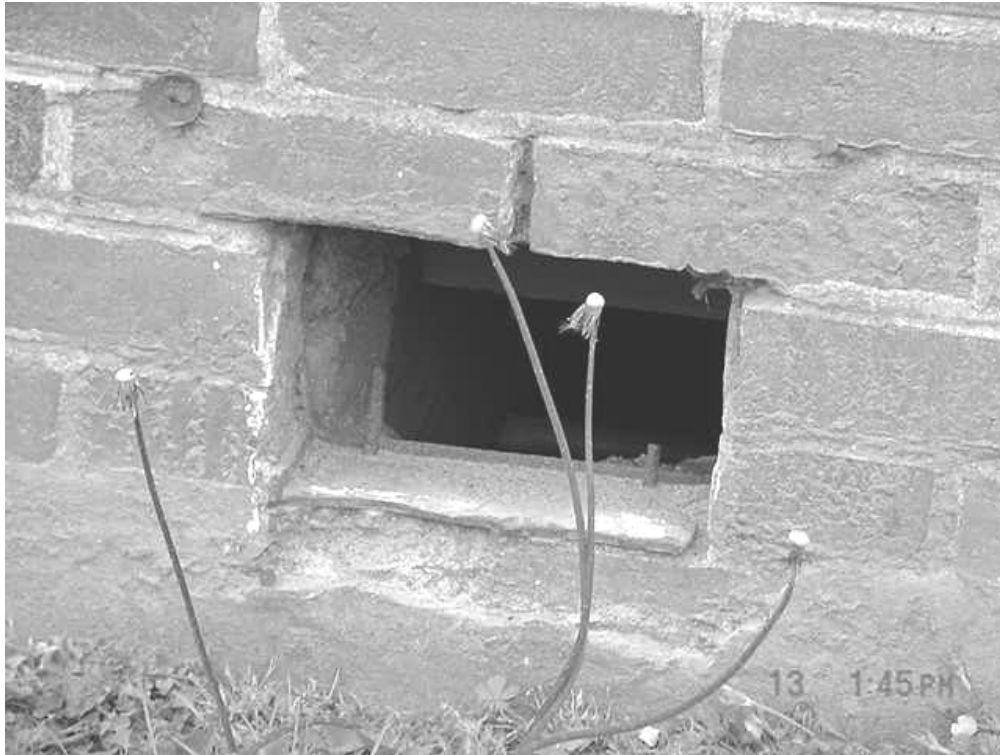
**Picture 10**

- Missing/damaged bricks (see Picture 10), holes and spaces in exterior walls of the building.
- Small trees/stumps, and other plants were growing in the tarmac/exterior wall junction. The growth of roots/plants against the foundation/exterior walls of the building can bring moisture in contact with wall brick and eventually lead to cracks and/or fissures in the foundation below ground level.
- The gutter/downspout system along the roof was either missing or in disrepair (see Picture 11). Gutters and downspouts are designed to direct rainwater away from the base of the exterior walls. In some cases the gutter/downspout system empties water directly against the foundation or into the crawlspace (see Pictures 12 & 13). These conditions can undermine the integrity of the building envelope and provide a means of water entry

**Hole in Building Envelope Near Foundation of Building**

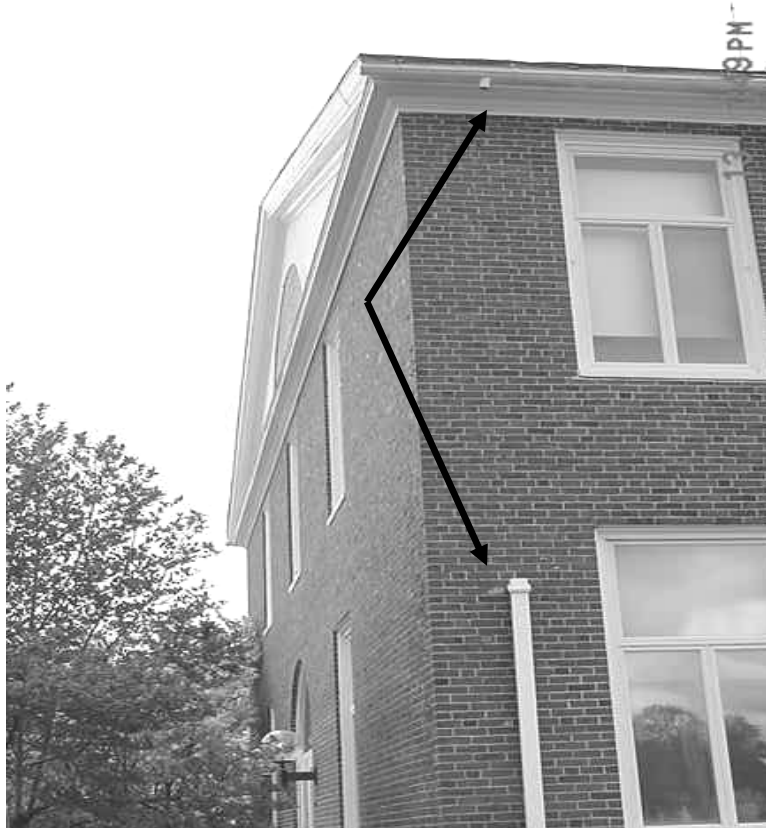
**Picture 11**

**Damaged/Missing Gutter/Downspout System**

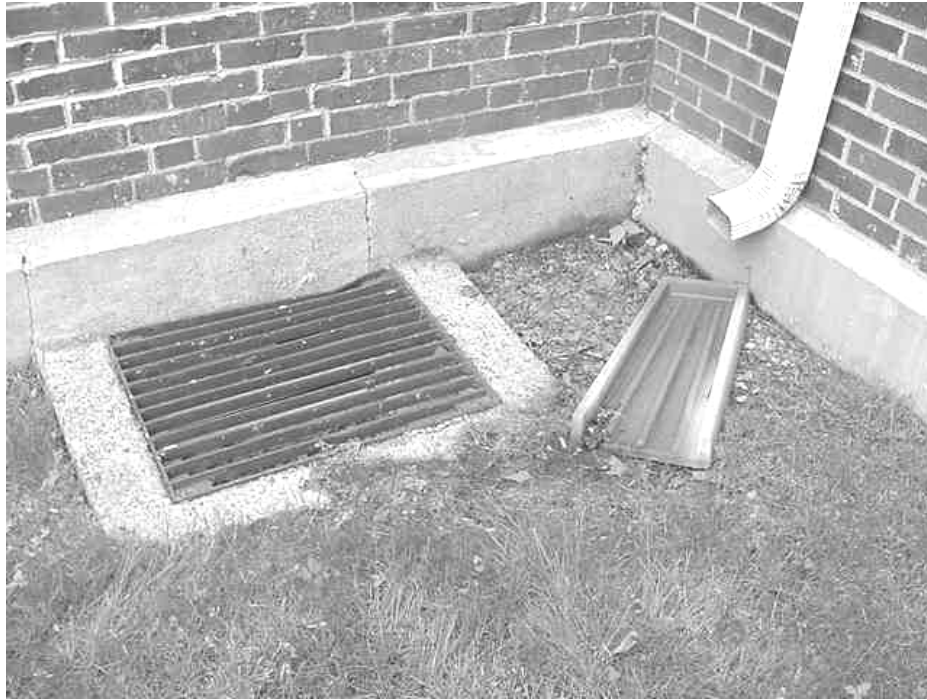
**Picture 12**

**Gutter/Downspout System Emptying Water into Crawlspace Grate**

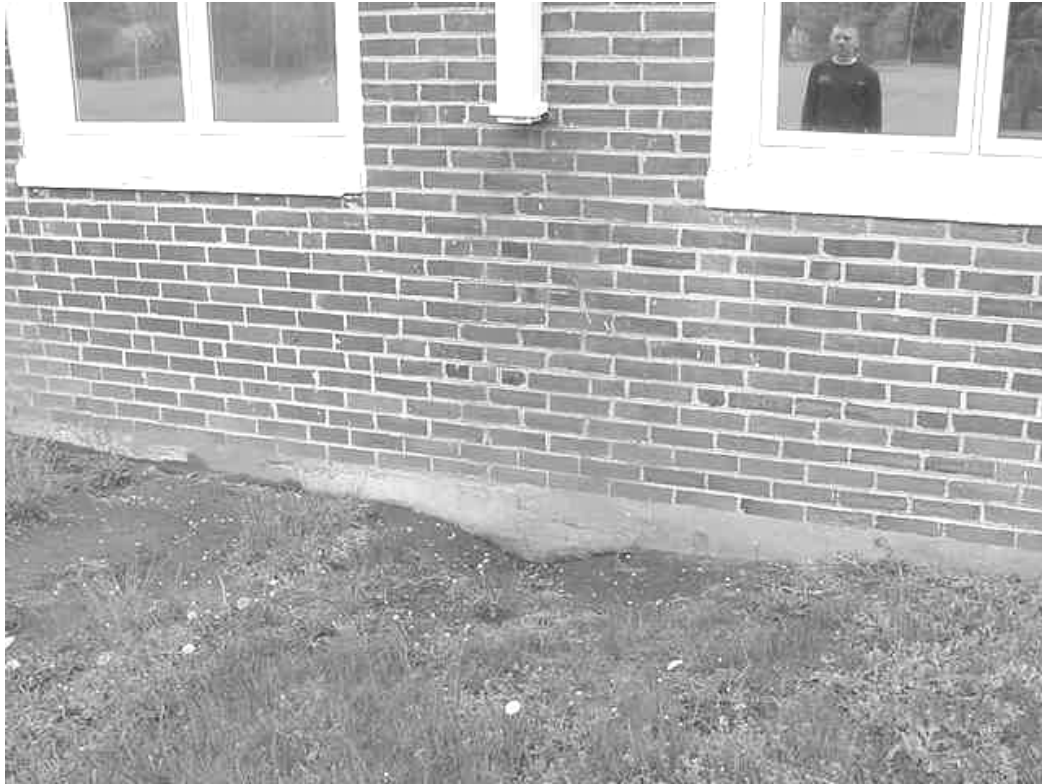
**Picture 13**

**Gutter/Downspout Emptying Water Directly Against the Foundation, Note Depression Pit Downspout**

2. To prevent moisture penetration into the crawlspace, the following actions should be considered:
  - a. Improve the grading of the ground away from the foundation at a rate of 6 inches per every 10 feet (Lstiburek and Brennan, 2001).
  - b. Install a water impermeable layer on ground surface (clay cap) to prevent water saturation of ground near foundation (Lstiburek and Brennan, 2001).
  - c. Move foliage to no less than five feet from the foundation.
3. Remove and replace any mold contaminated/water damaged building materials in the crawlspace. This measure will remove actively growing mold colonies that may be present. Remove mold contaminated materials in a manner consistent with recommendations found in *Mold Remediation in Schools and Commercial Buildings* published by the US Environmental Protection Agency (US EPA) (US EPA, 2001).

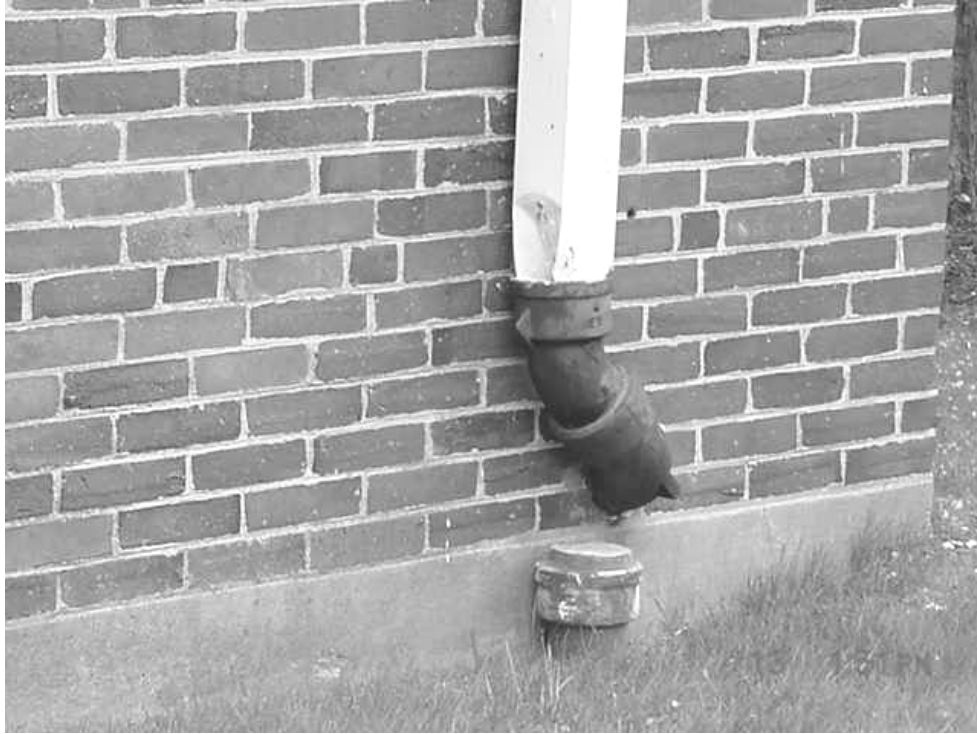
**Picture 14**

- The original underground drainage system appears to have been abandoned and rerouted back into the building (see Picture 14). Town officials had no information concerning the path of the drainage system or when these alterations were made. Mr. Winkleman informed BEHA staff that the town was in the bidding process contracting out work for the building's drainage system.

**Current Drainage System Re-routed through the Brick Into the Interior of the Building, Original Underground Drain Sealed below**

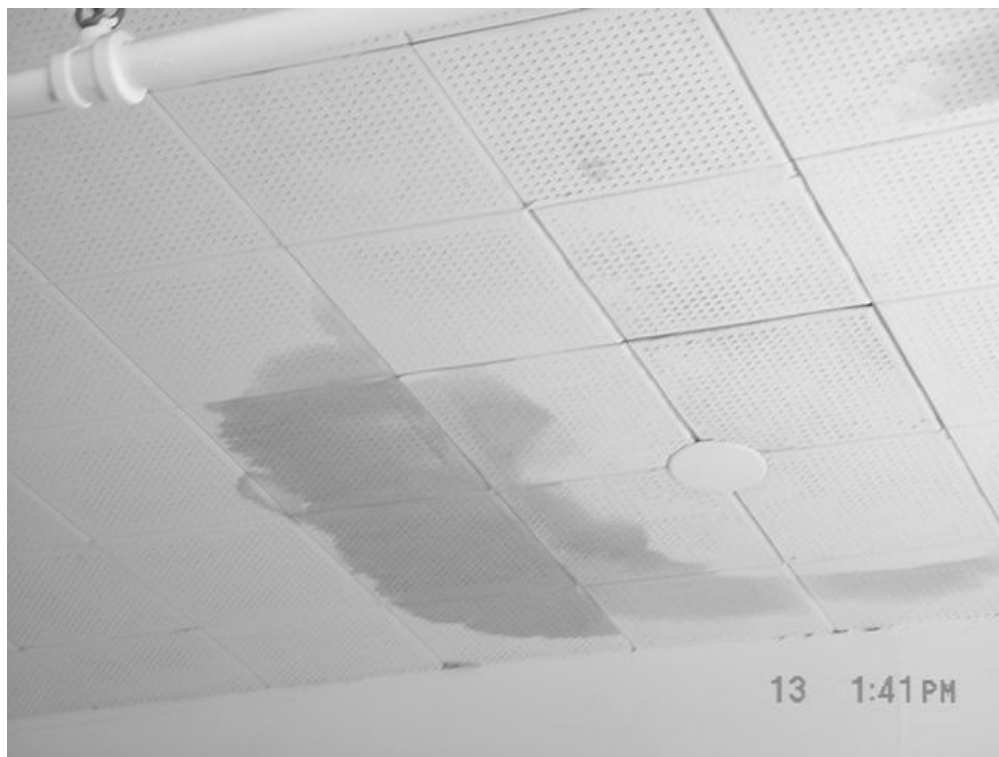
**Picture 15**

A number of areas had water-damaged building materials (e.g. stained ceiling tiles, peeling paint) (see Pictures 2, 15 & 16) that were unrelated to the sprinkler system rupture. These water damaged building materials are evidence of roof or plumbing leaks. Active leaks were reported in several areas of the building and a number of buckets were observed in the attic, apparently stationed to collect rainwater (see Picture 17). Water-damaged ceiling tiles can provide a source of mold and mildew and should be replaced after a water leak is repaired.

**Stained-Interlocking Ceiling Tiles**

10. Work with a roofing contractor to identify and repair leaks. Replace any water-stained ceiling tiles and building materials. Examine the area above and around these areas for mold growth. Disinfect areas of water leaks with an appropriate antimicrobial.
11. Continue with plans to hire a contractor to repair the downspout and gutter systems that direct water away from the building.
12. Seal holes/breaches in the building envelope to prevent water penetration and pests.
13. Change filters in air handling equipment as per the manufacturer's instructions to prevent the re-aerosolization of dirt, dust and particulate matter.
14. For further building-wide evaluations and advice on maintaining public buildings, see the resource manual and other related indoor air quality documents located on the MDPH's website at <http://www.state.ma.us/dph/beha/iaq/iaqhome.htm>.

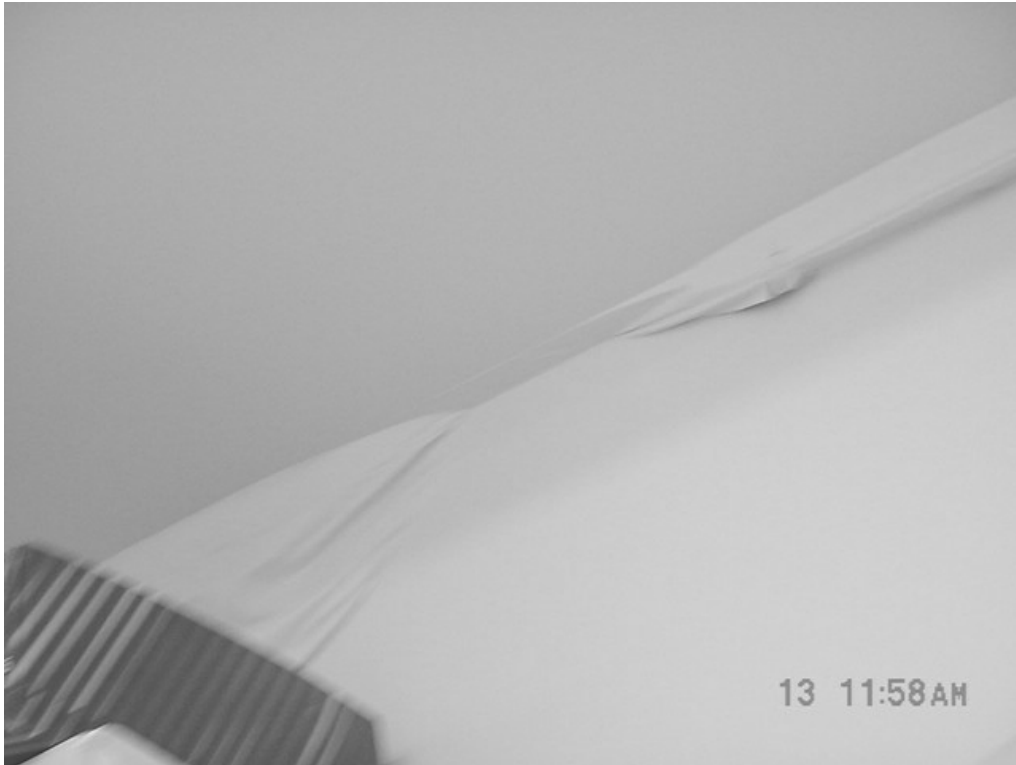
**Picture 16**

**Peeling/Water-Damaged Paint**

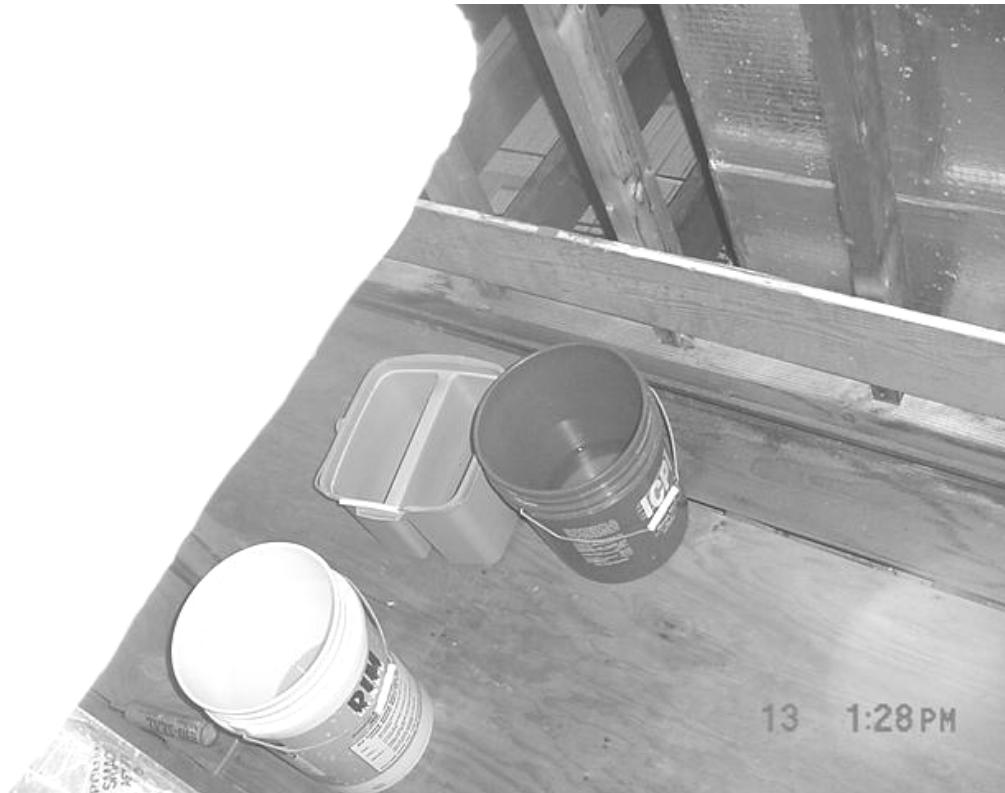
**Picture 17**

**Buckets (Partially Full) in the Attic to Collect Rainwater**

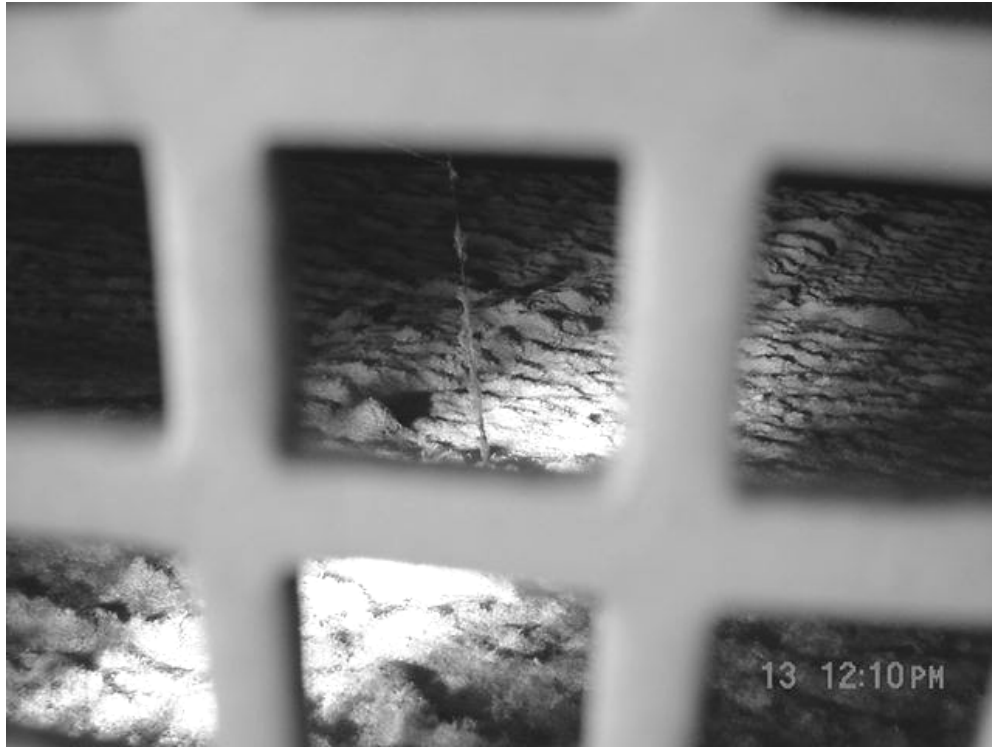
**Picture 18**

Finally, the return vent located under the stage in the gymnasium/auditorium contained 1” to 2” of accumulated dust and debris (see Picture 18). This system was not operating during the assessment. If exhaust vents are not functioning, backdrafting can occur, which can aerosolize dust particles. In addition, these materials can accumulate on flat surfaces and subsequently be re-aerosolized.

**Accumulated Dirt, Dust and Debris in Return Vent under Stage in Gymnasium Auditorium**
